Bureau of Reclamation
Missouri Basin Region
Geology and Exploration Services Group

TRAVEL REPORT

Subject: Inspection of New Landslide at Green Mountain Dam, Colorado

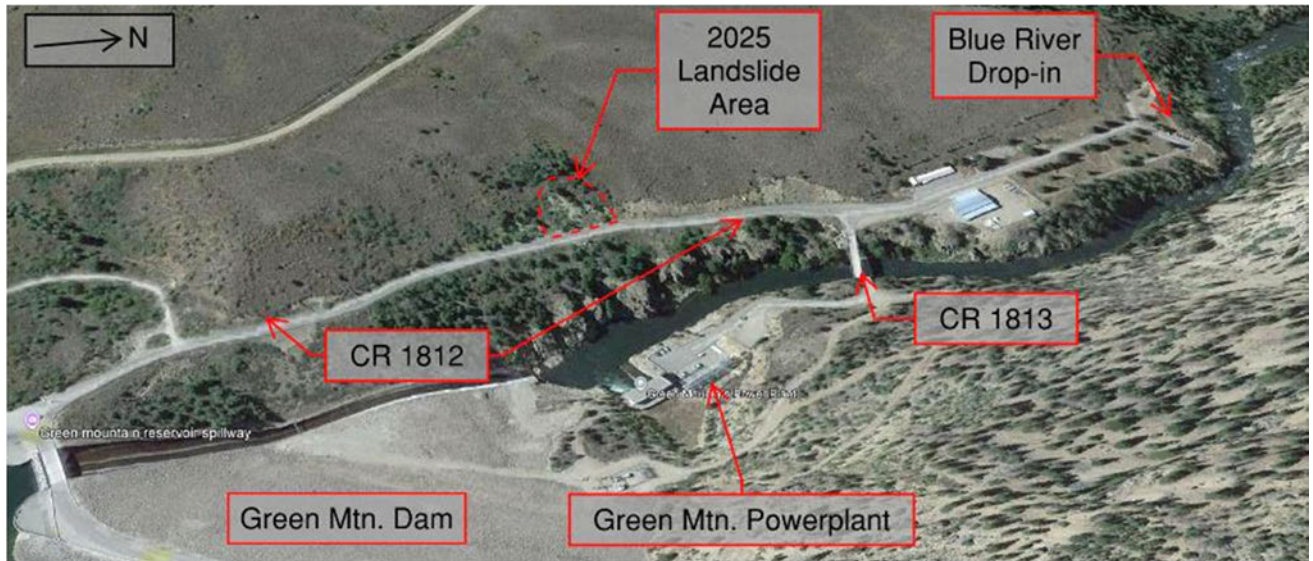
The purpose of this trip was to inspect the recent landslide above Summit County Road 1812 (CR 1812), located downstream of the left abutment above the spillway of Green Mountain Dam. This road serves as access to the Green Mountain Powerplant and the Blue River boat drop-in (Figure 1).

Figure 1 – An overview of the 2025 landslide area in relation to the Green Mountain Dam and Powerplant, the county roads, and the public Blue River boat drop in point. CR 1812, which is currently closed, is the only developed roadway that leads to the boat drop in. Satellite imagery from Google Earth (2019)

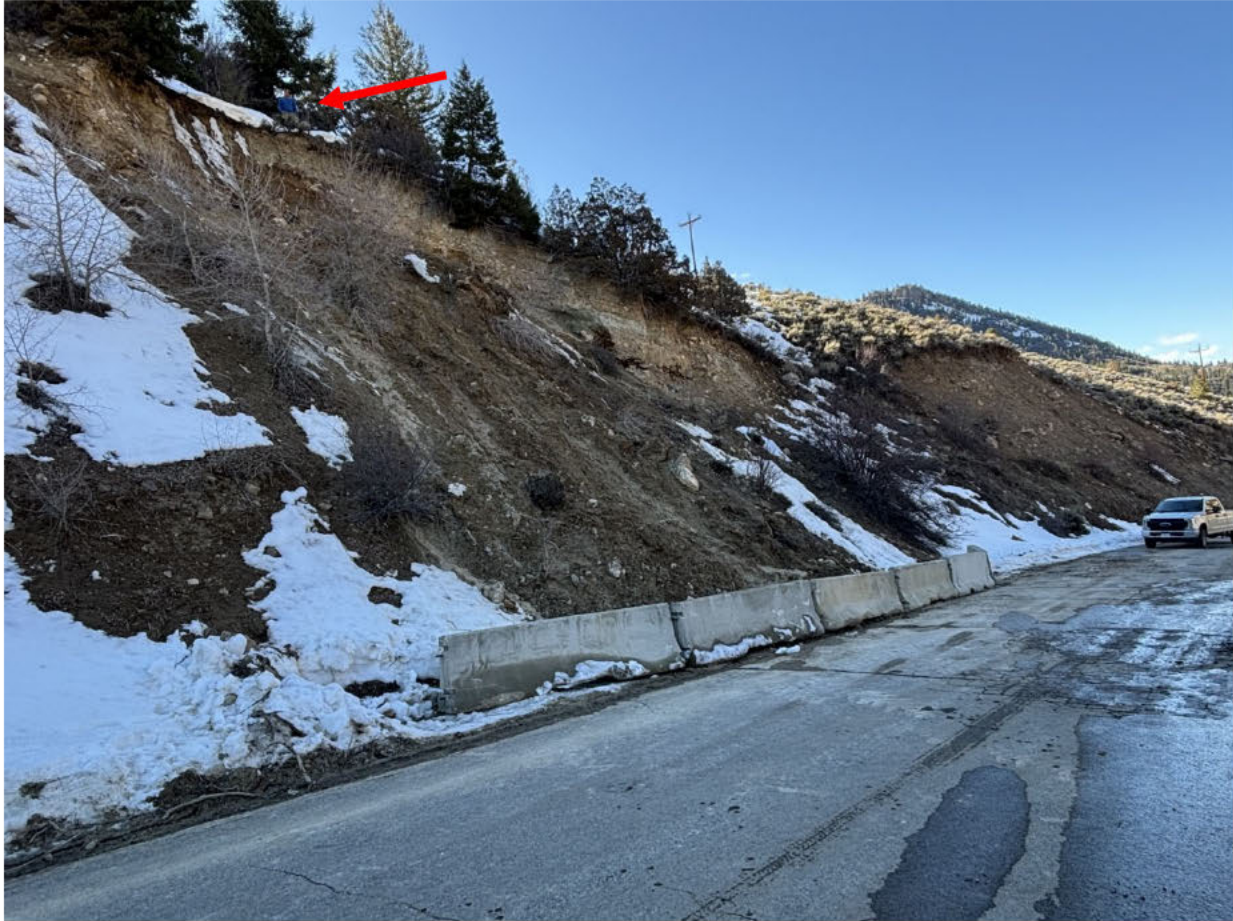
The access road was closed to the public on March 27 and remains closed as of June 2025. The slide scarp is approximately 60-70 feet wide at the base and has a 10- to 20-foot-tall active scarp. The difference in elevation from the road to the top of the scarp is 60 feet (Figure 3).

Figure 3 – A northwest facing view of the recent landslide taken shortly after the initial slide prior to this site visit. There is a person in a blue jacket at the top of the slide, marked by an arrow, for scale. The head scarp is approximately 10-20 feet tall. Some cobbles and boulders are seen sliding down the slope.
Photo by T. Kummer (USBR) – 3/17/2025

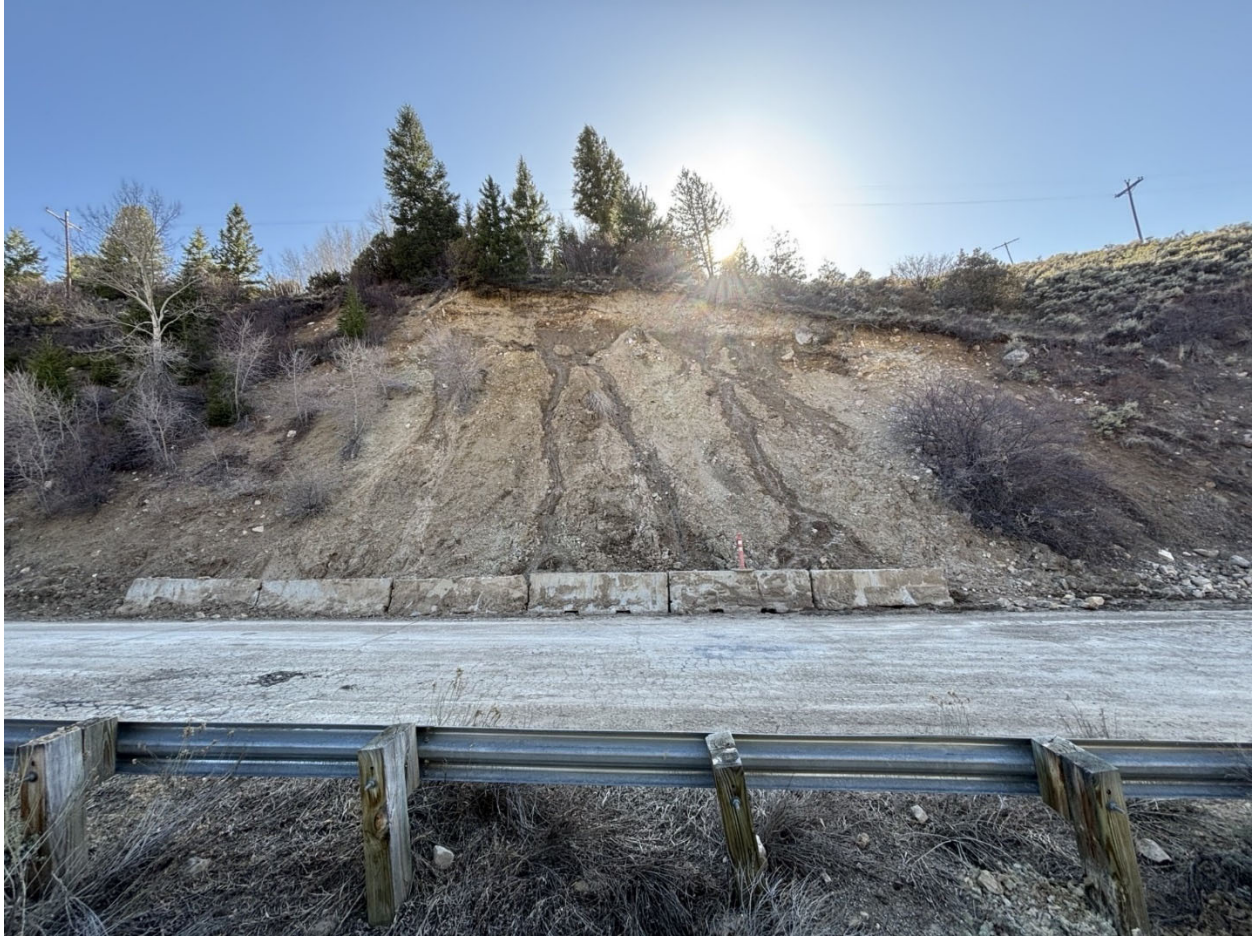
The slide area's geology consists of unconsolidated glacial till with zones of clay or shale beds that have been incorporated into the slide and act as an impermeable layer. Perched water tables may develop on less pervious beds, allowing water to flow at shallow depths within the hillside (Figure 4). During the team's onsite visit, active water flow was noted approximately two-thirds up the landslide slope face. The flow was only seeping, but there was enough water exiting the scarp to saturate some of the slide debris covering the bottom half of the slope (Figure 5). The quantity was a fraction of the water exiting the scarp just after the large slope failure on March 11th (Figure 6) and in early April (Figure 4).

Figure 4 – A west facing view of the landslide taken prior to this site visit. Groundwater is seen exiting the slide in multiple areas along a similar plane. This plane is evidence of perched water tables bound by an impermeable layer of rock or soil.

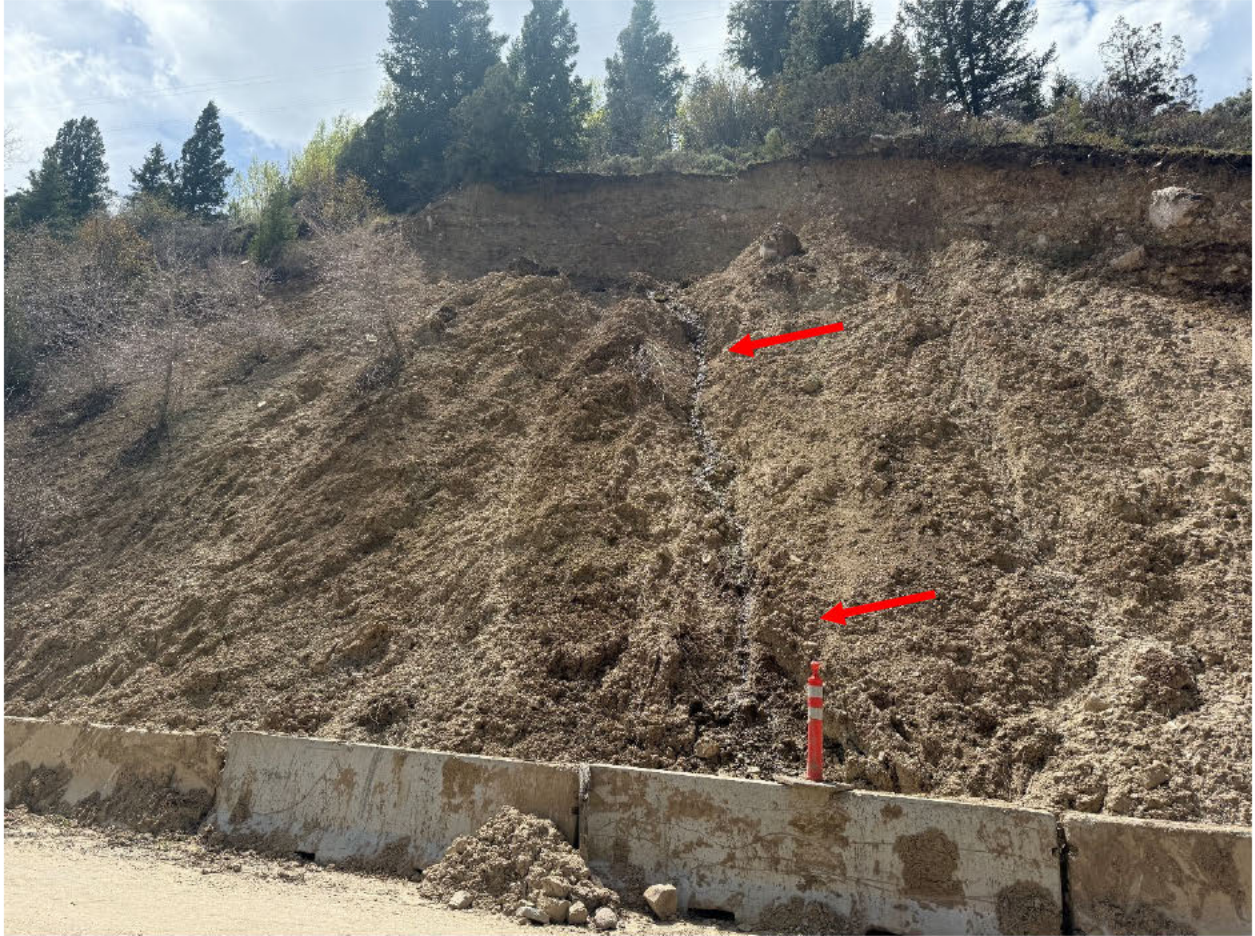
Figure 5 – A photo of groundwater exiting from the slide face seen during our site visit. The water exiting the slide is creating an erosional channel and saturating slide deposits towards the toe. The amount of water seen during our visit was minor compared to the amount of water seen exiting the slope following the larger slide events in March and April.

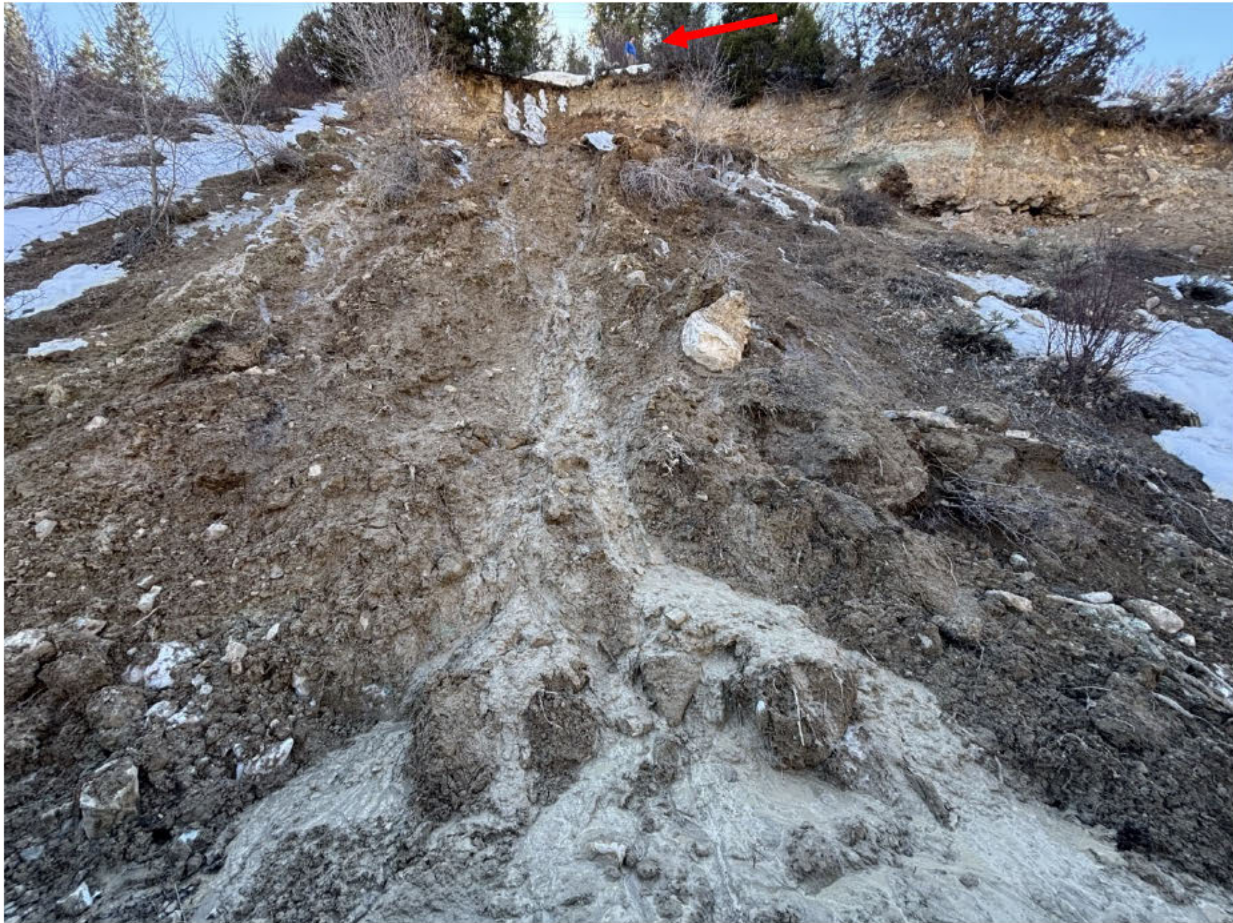
Figure 6 – A west facing view of the landslide taken from the toe. There is a person in a blue jacket at the top of the slide, marked by an arrow. The head scarp is approximately 10-20 feet tall. Some cobbles and boulders are seen coming down the slope. The slide debris in the foreground has a soft and saturated consistency due to the amount of water exiting the slide face.

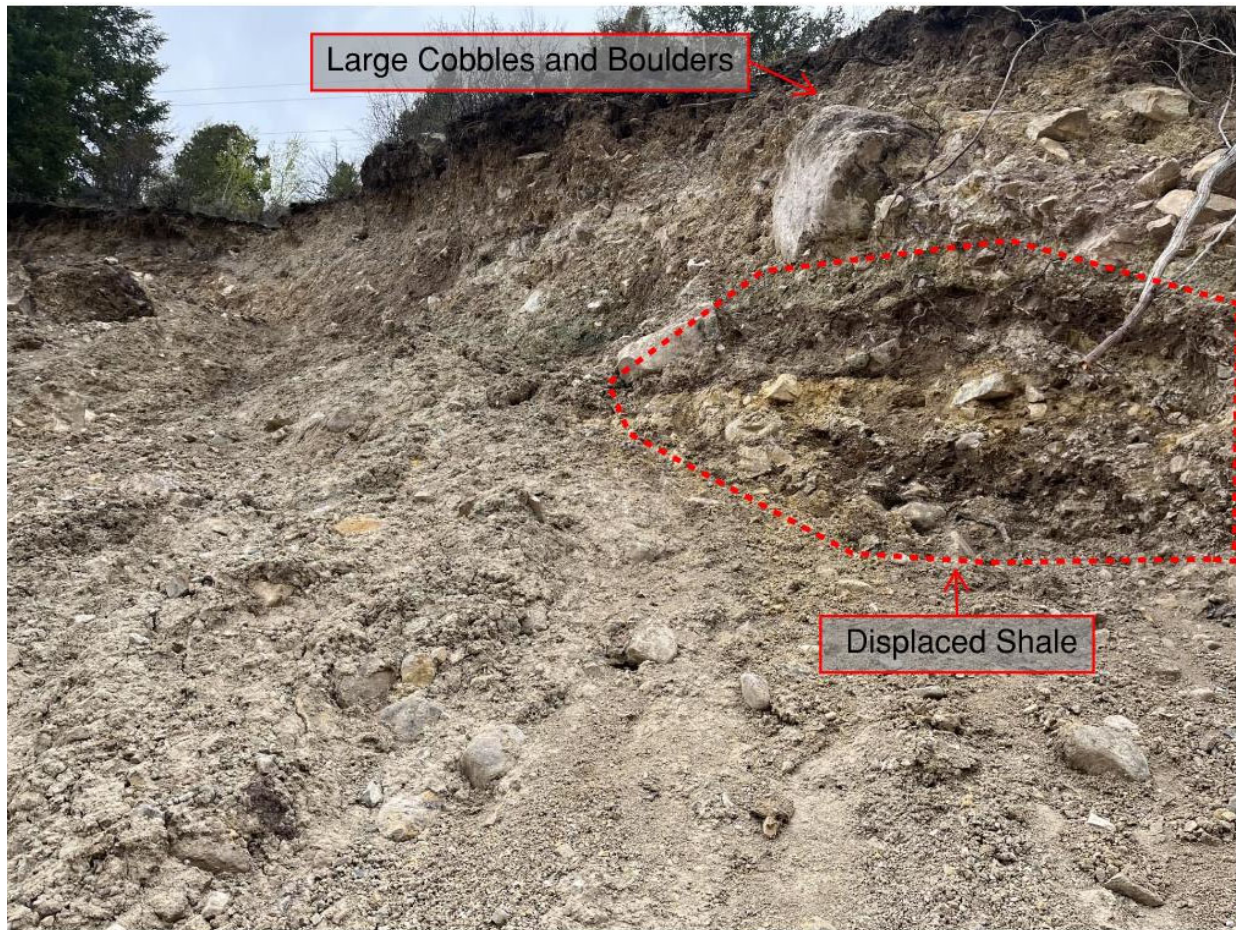
The unconsolidated materials in the scarp are a heterogeneous mix of clay, silt, sand, gravel, cobbles, and occasional boulders up to 24 inches in diameter (Figure 7). The material exposed in the scarp ranges from matrix supported to clast supported. Most of the material exposed in the scarp is a coarse-grained soil containing a high percentage of gravels, cobbles and boulders, however it varies widely throughout the slide area. Pockets of finer grained materials exist with only a trace of cobbles and boulders. Cobbles and boulders range from angular to subrounded and from hard sedimentary sandstone and crystalline rocks to soft decomposed shales. Some of the material is oxidized. Geologic investigations in the Heeney slide area in 2003 found a wide range of permeabilities in the glacial deposits. Therefore, some glacial sediments may create perched water tables or not adequately drain.

Several decomposed beds of displaced shale were observed in the scarp of the recent slide, indicating weathered shale bedrock units were also involved in the slide (Figure 7). Translational sliding can explain how shale blocks were incorporated into glacial deposits.

Figure 7 – A close up view of the slide materials in the right (northwest) flank of the recent 2025 slide scarp. Blocks of maroon and ochre displaced shale are circled on the right. This shale could have been incorporated into glacial materials by translational sliding. Also shown is the amount of variation within the size of material within the scarp, ranging from very fine clays and silts up to large boulders and cobbles.

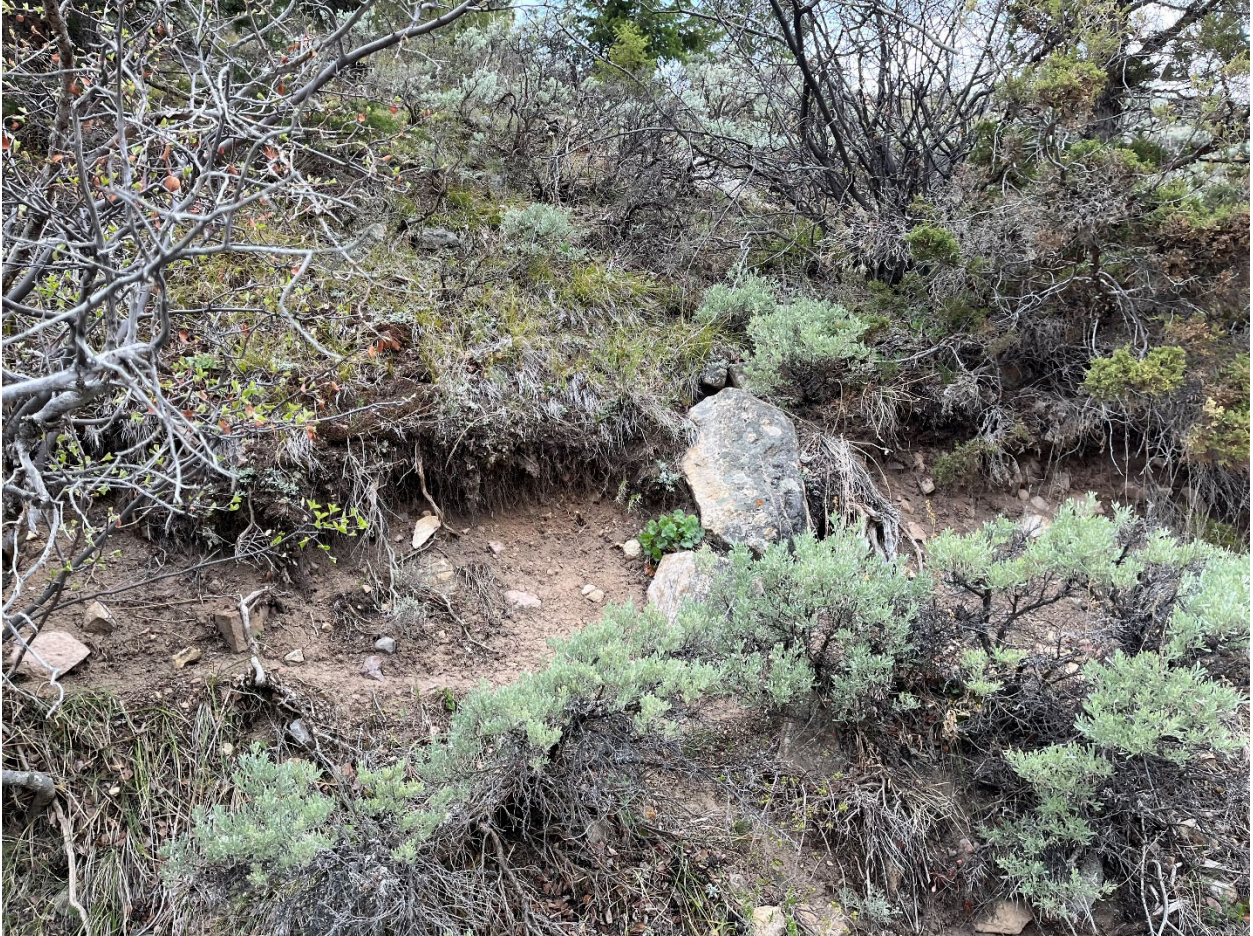
The recent slide appears to be within a larger, deeper-seated slide that predates this sliding event. Larger arcuate scarps at the crown with about 1-2 feet of displacement were noted between about 30-60 feet uphill of the head scarp of the 2025 slide [REDACTED]. The scarps were unvegetated indicating relatively recent offset, probably within the last 5 years (Figure 9). The displaced and highly weathered shale beds exposed in the landslide scarp also indicate that the recent slide could be part of a deeper-seated slide. This is concerning since the 2025 slide will have decreased the stability of the older slide, because it has removed some of the material supporting the toe, potentially reducing the slope materials' shear strengths.

Figure 9 – A southwest facing view of one (less than 2 foot tall) scarp located above the major landslide area. Many small scarps forming a larger arc were seen above the recent slide area during our investigation. These indicate surficial material upslope from the powerplant access road is susceptible to soil creep. They could also possibly be along the failure plane of a future, larger rotational slide.
Photo by C. Clark (USBR) – 5/5/2025

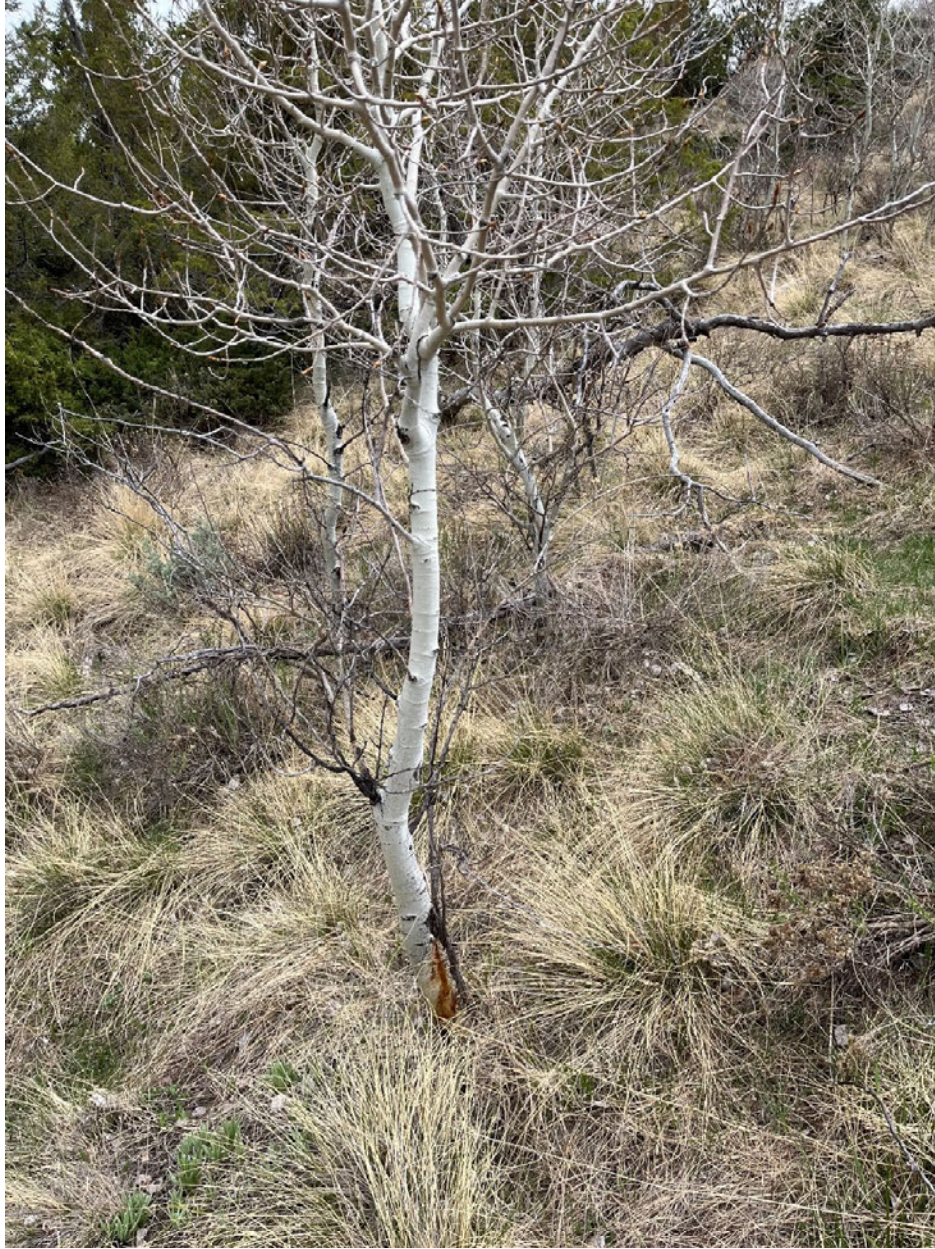
A grove of aspen trees at the top of the head scarp indicates a perennial presence of groundwater directly upslope from the slide area (Figure 2). The aspen trees vary in age with trees ranging from about 10 to 30 feet tall. Some of the younger aspens, 10-20 feet tall, had distinctly bent trunks about 1-2 feet above the base of the trunk (Figure 10). This indicates a period of slumping that could have occurred within the last 5 years, estimating tree growth of several feet per year. Power poles cross the top of the slide were standing vertically with no indication of movement [REDACTED]. However, movement could be near vertical near the top of the slide area.

Figure 10 – A southeast facing view of one warped tree located above the recent landslide area. This warping of the tree trunk shows that during growth the soil underneath has slumped downslope, and the tree had to bend to continue growing vertically. There were many warped tree trunks seen upslope of the slide area during this investigation. The age of the trees and the height of the bend in the trunk are evidence that the slope has been slumping within the last 5 years.
